# Long Branch Green Team & Environmental Commission

## Spotlight topic: the Saga of the Stone Hut at Ross Lake Park

## Stone Hut Restoration

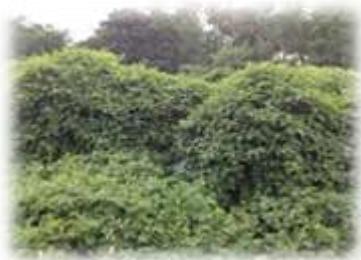
Over time, the hut was abandoned, and both the island and the banks on the shore became overgrown. Preliminary cleanup efforts started in 2011, led by the Whale Pond Brook Watershed Association, and supported by the Environmental Commission, Green Team and the city. At right is a picture from April 2011 when volunteer cleanups began. Notice that the entire island is completely obscured by the growth on the Elinore Ave bank. Local residents didn't even realize there was an island until the growth was cleared from both the island and the mainland!

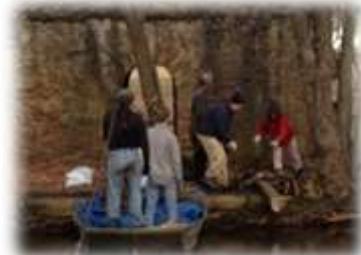
In December 2013 the Long Branch DPW cleared 250 feet of land on the north side of Ross Lake and removed dead trees from the lake.

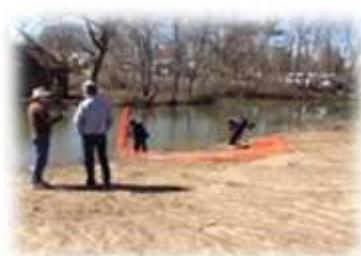
That February Monmouth County and Long Branch City jointly funded the dredging of Ross Lake.

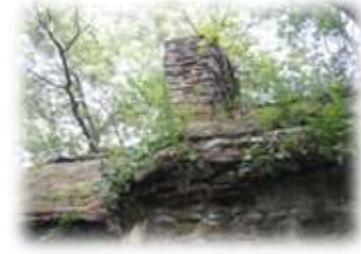
The restoration proceeded in phases. Phase I, 2013-2014, involved tree/root removal. In the before photos at left, notice the trees growing out of the roof.

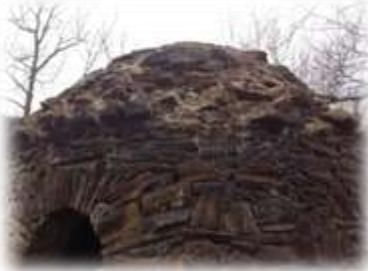
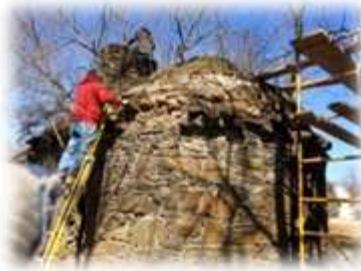
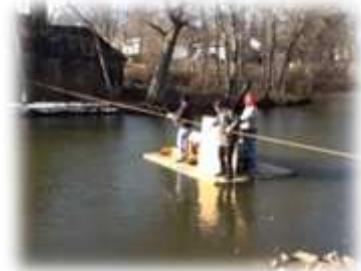
Afterwards, the roof was cleared, however many of the stones either fell off or had to be removed to get to the roots. The mason, Ken Manzi, kept all the stones to be used in Phase II. He built a raft to transport his men and supplies. Afterwards, volunteers used the raft to haul brush from the island to the mainland.

In Phase II, 2015-16, mortar and stone on the north side of the hut was restored.

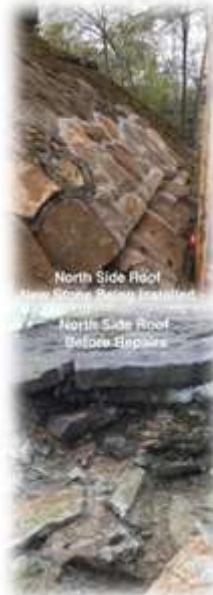
During Phase III, spring 2017, damage was discovered on the eastern side of the roof. As you can see, a lot of the stones and mortar fell out when the tree roots were removed in Phase I. In November 2017 the entire stone hut was covered with a tarp to help protect it from damaging freezing and thawing. Between the "john boat" loaned by Monmouth University and the raft made by Kevin Manzi, the mason for Phase I, II and III, 10 people were taken over to the island to cover the hut and stake down the tarp.

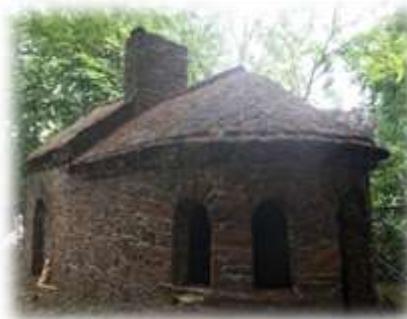
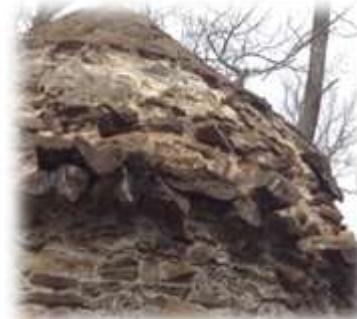
Phase IV of the restoration was completed in 2023. Scott Cardalfe, Rock Masonry, was our mason for the fourth and final restoration phase. He began by removing all the vegetation from the roof, again. Then, after hunting down more peanut stone, they finished the eastern side.

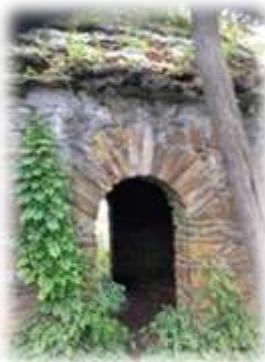
We love this stone hut for many reasons, one being that the craftsmanship of the stone masons is abundantly evident and demonstrates a love of the craft. There are three beautifully arched doorways and 4 arched windows.

The stonework around the doors and windows forms a beautiful pattern. There is a huge fireplace in one room. Stones are arranged in a flower pattern in the room behind the fireplace.
